Fukushima Daiichi Status Report

27 July 2012

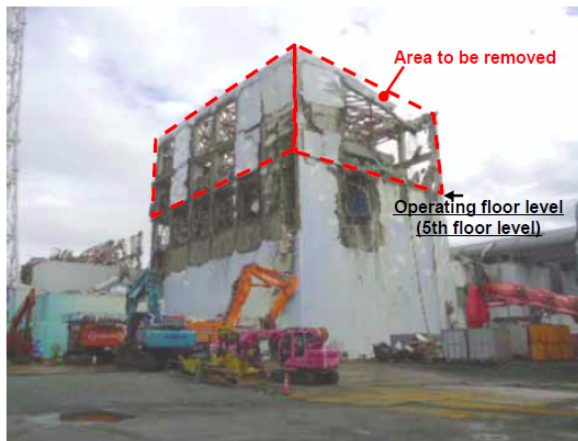
Before debris removal (Southwest surface)
Photo taken on September 22, 2011

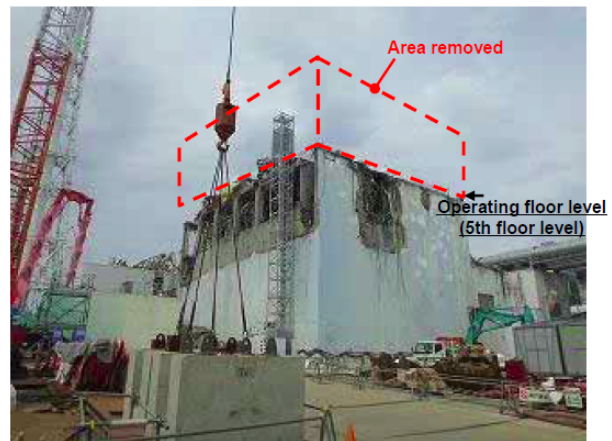
After debris removal completion (Southwest surface)
Photo taken on July 5, 2012

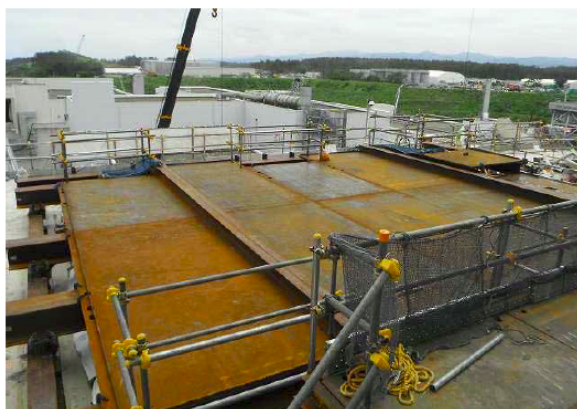
Protection platform installation on the
Spent Fuel Pool
Photo taken on June 15, 2012

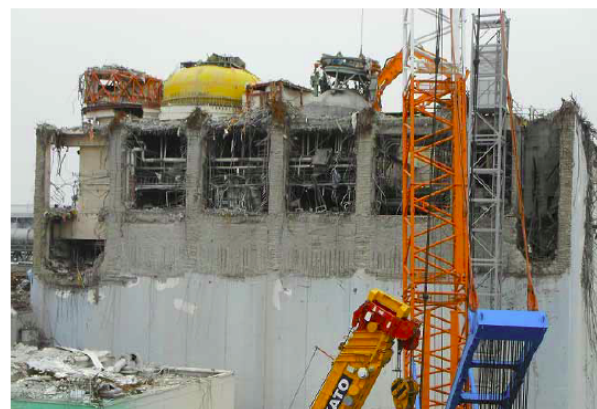
After debris removal
(Upper part of the operating floor, west surface)
Photo taken on July 9, 2012

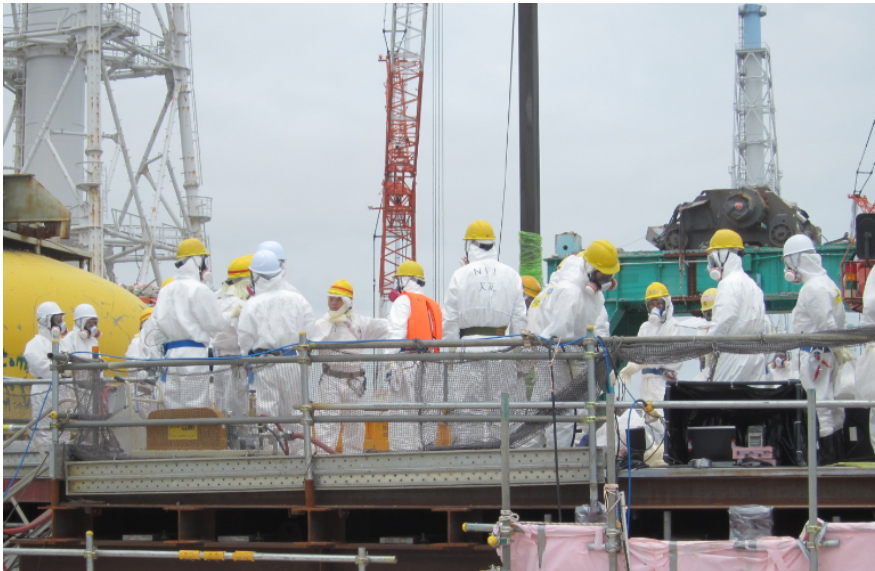
Figure 29: Unused fuel bundle being lifted out of the Unit 4 Spent Fuel Pool

On 19 July NISA [reported](#) that TEPCO had successfully [conducted](#) an operation to remove two unused fuel assemblies (un-irradiated) from the Unit 4 Spent Fuel Pool. Both assemblies were moved to the Common Spent Fuel Pool. These fuel bundles will be examined to determine if there is a serious risk of corrosion on the other fuel bundles currently stored in the Unit 4 Spent Fuel Pool. Figure 29 shows one of the bundles being lifted out of the pool with workers in the foreground. Figure 30 shows the bundles wrapped in a plastic covering prior to transport.
